**WATER & SEWER
COMMISSION**

**Summer & Cottage Streets
Combined Sewer Separation Project
Inflow Investigation Report**

January 1999

Camp Dresser & McKee Inc.

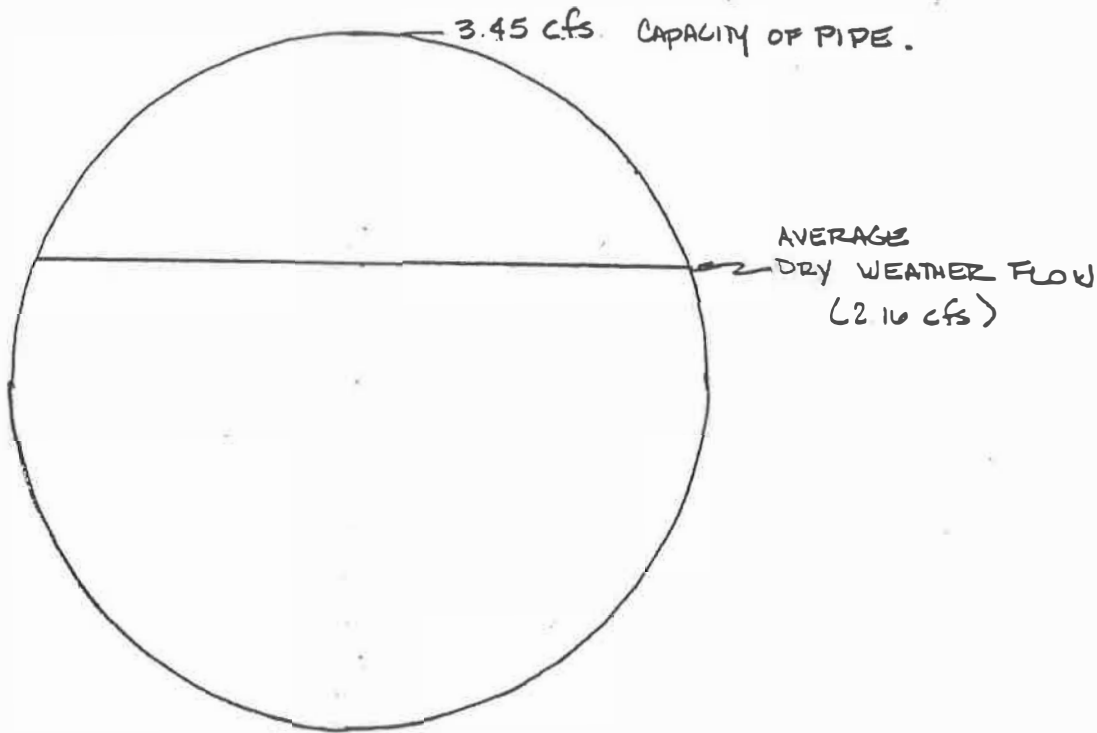
HYDRAULIC PROFILE

Figures included in Appendix B illustrate the calculated depth of flow in the 18" diameter sewer for three situations; 1) average dry weather flow plus infiltration; 2) average dry weather flow plus infiltration and sump pumps only and; 3) average dry weather flow plus infiltration, sump pumps and downspouts.

These illustrations show that even after catch basins have been removed from the combined system, the existing 18" sewer will surcharge under the assumed design conditions. Also included in Appendix B are figures illustrating calculated depths of flow for the same three conditions assuming the 18" diameter sewer is replaced with a 24" diameter pipe.

18" Ø PIPE

----- PLUS SUMP PUMPS (5.72 cfs.)
(ESTIMATED)
